Design Report

**Loch Sport Erosion Protection –Shoreline
West of Seagull Drive Boat Ramp**

The State of Victoria Department of Energy,
Environment and Climate Action

Revision 0
Date 4 September 2025

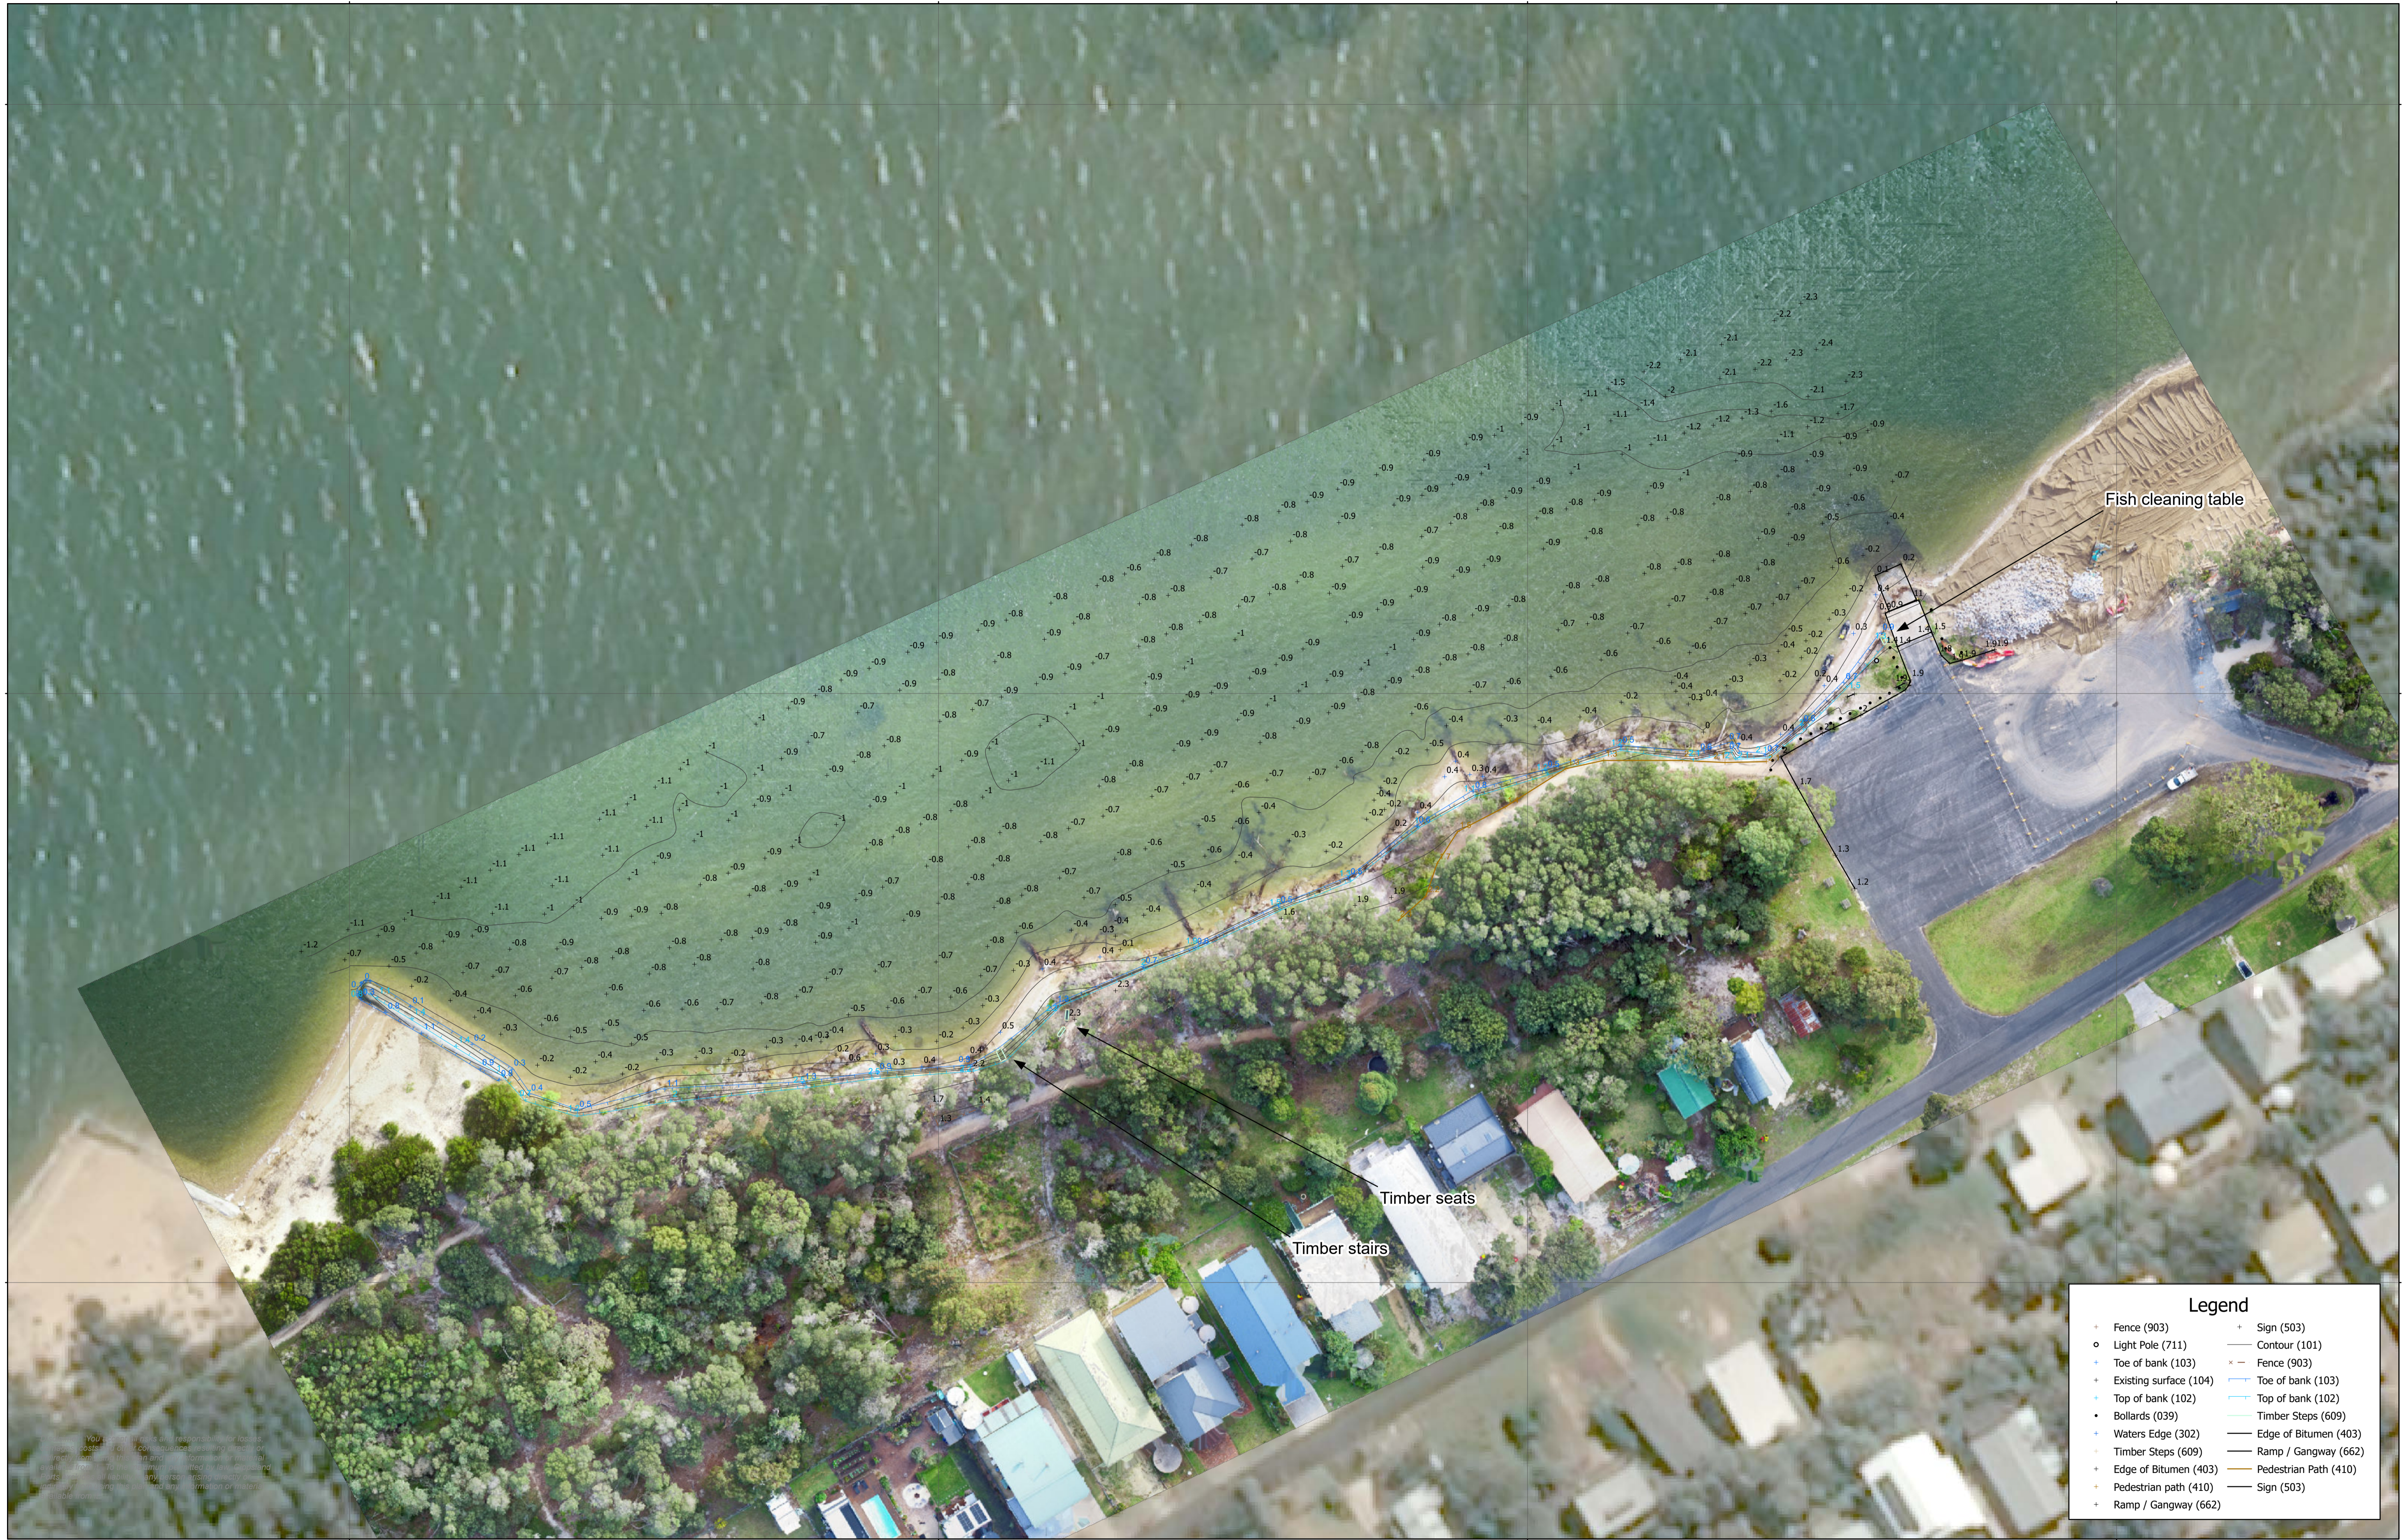
APPENDIX A SITE SURVEY

Amendment List			Equipment	Reliability
Date	Rev.	Description	CeeEcho 200kHz 9 degree beam survey system with Trimble RTK-GNSS for bathymetry and Trimble R12i GNSS rover for topo.	Depth Accuracy - ZOC A1 Position Accuracy - ZOC A1 Full bottom search not completed
				Previous Plan Numbers
				N/A

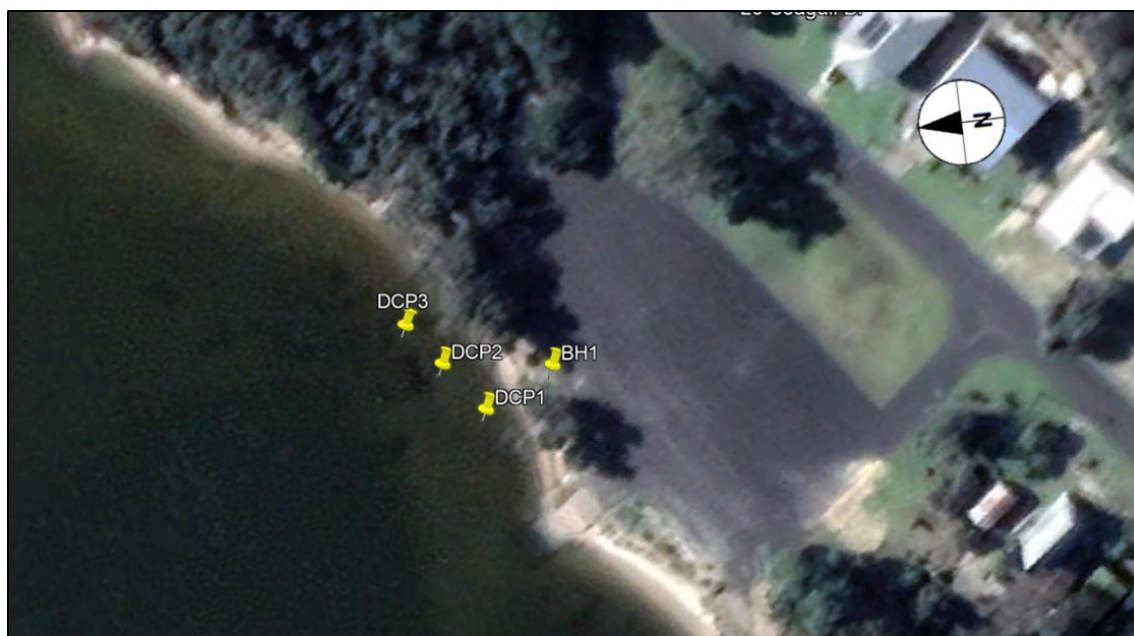
- Denotes Approximate Borehole and DCP Location (not to scale)

The fieldwork was performed in the presence of a Geotesta geotechnical engineer who positioned boreholes and DCP locations based on the client requirement and considering safety of the field engineers. Collected samples prepared borehole logs in accordance with AS 1726 – 2017 "Geotechnical site investigations". Field observations and in-situ test results are presented in borehole logs attached in **Appendix A** of this report.

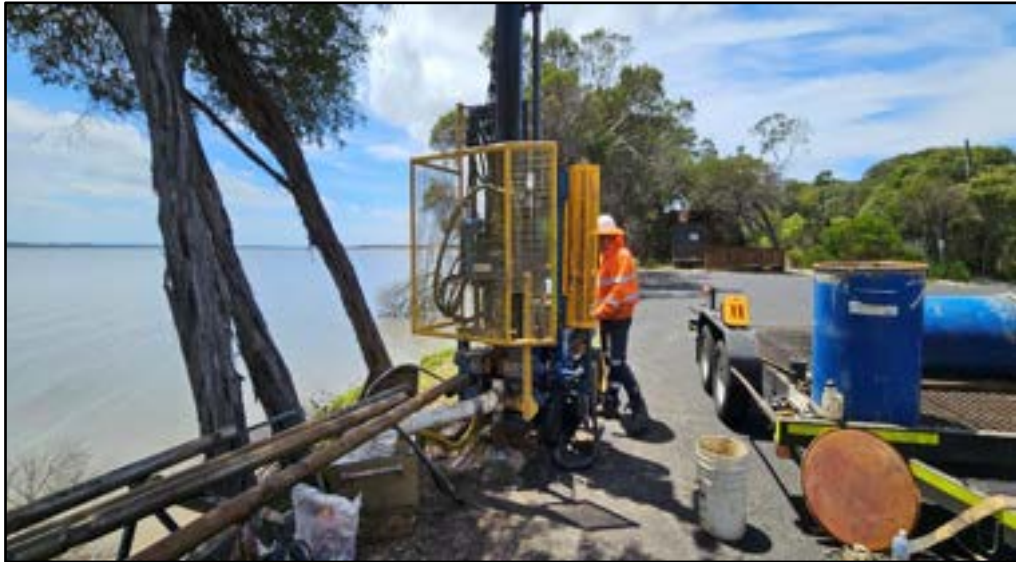
Borehole BH1 location; looking at west

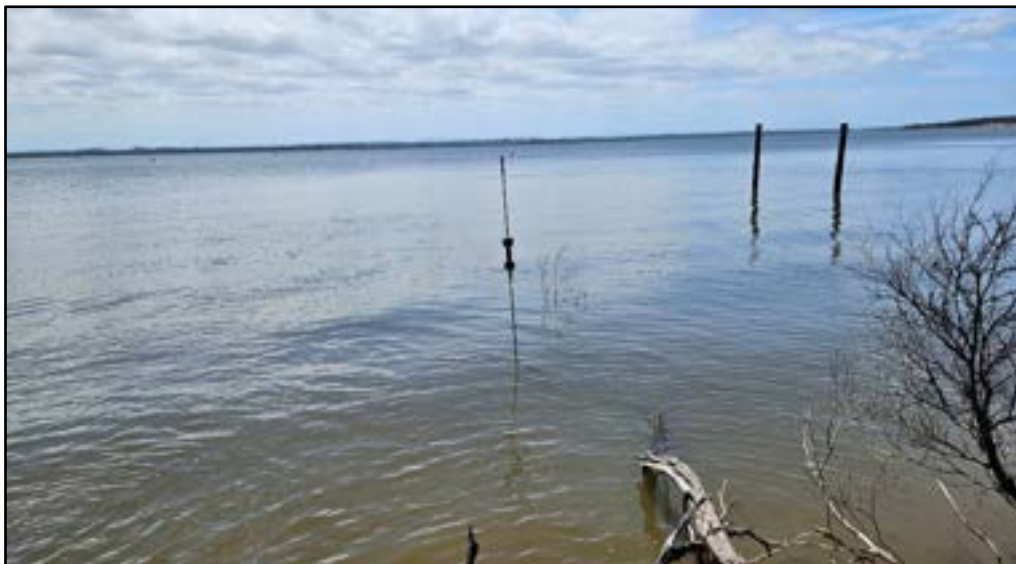
DCP1 testing location; looking at east

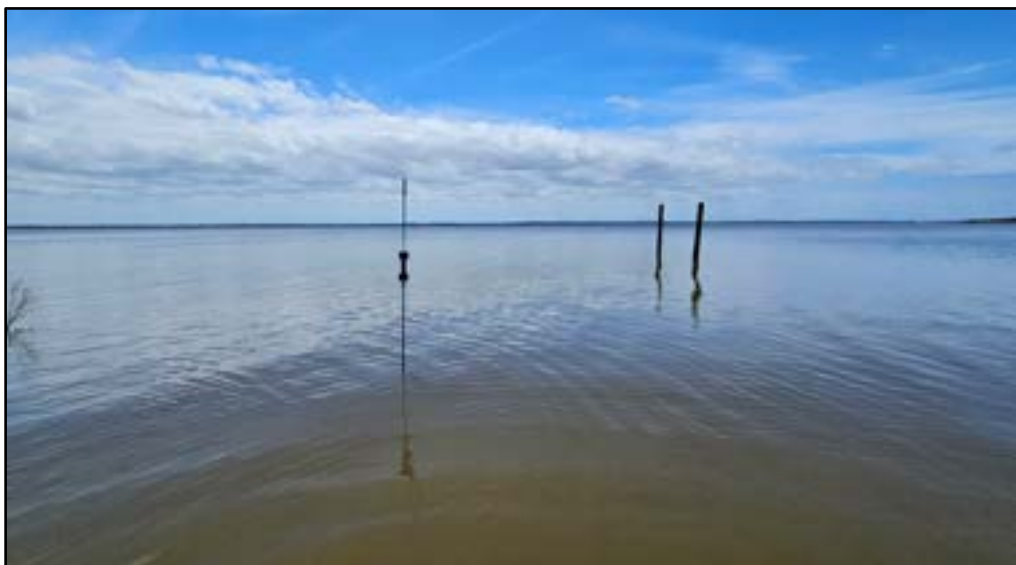
DCP2 testing location; looking at south

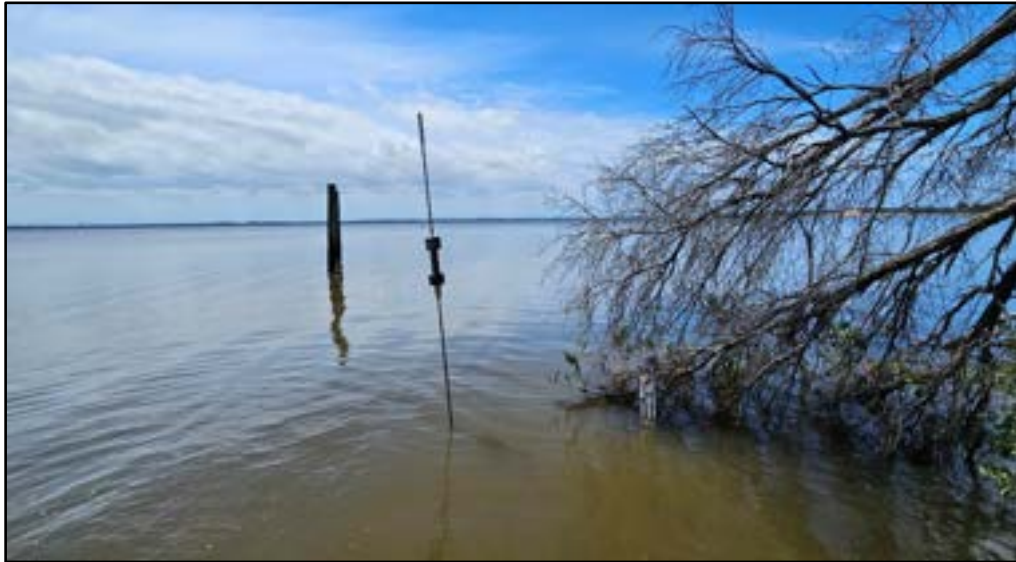
DGP3 testing location; looking at east

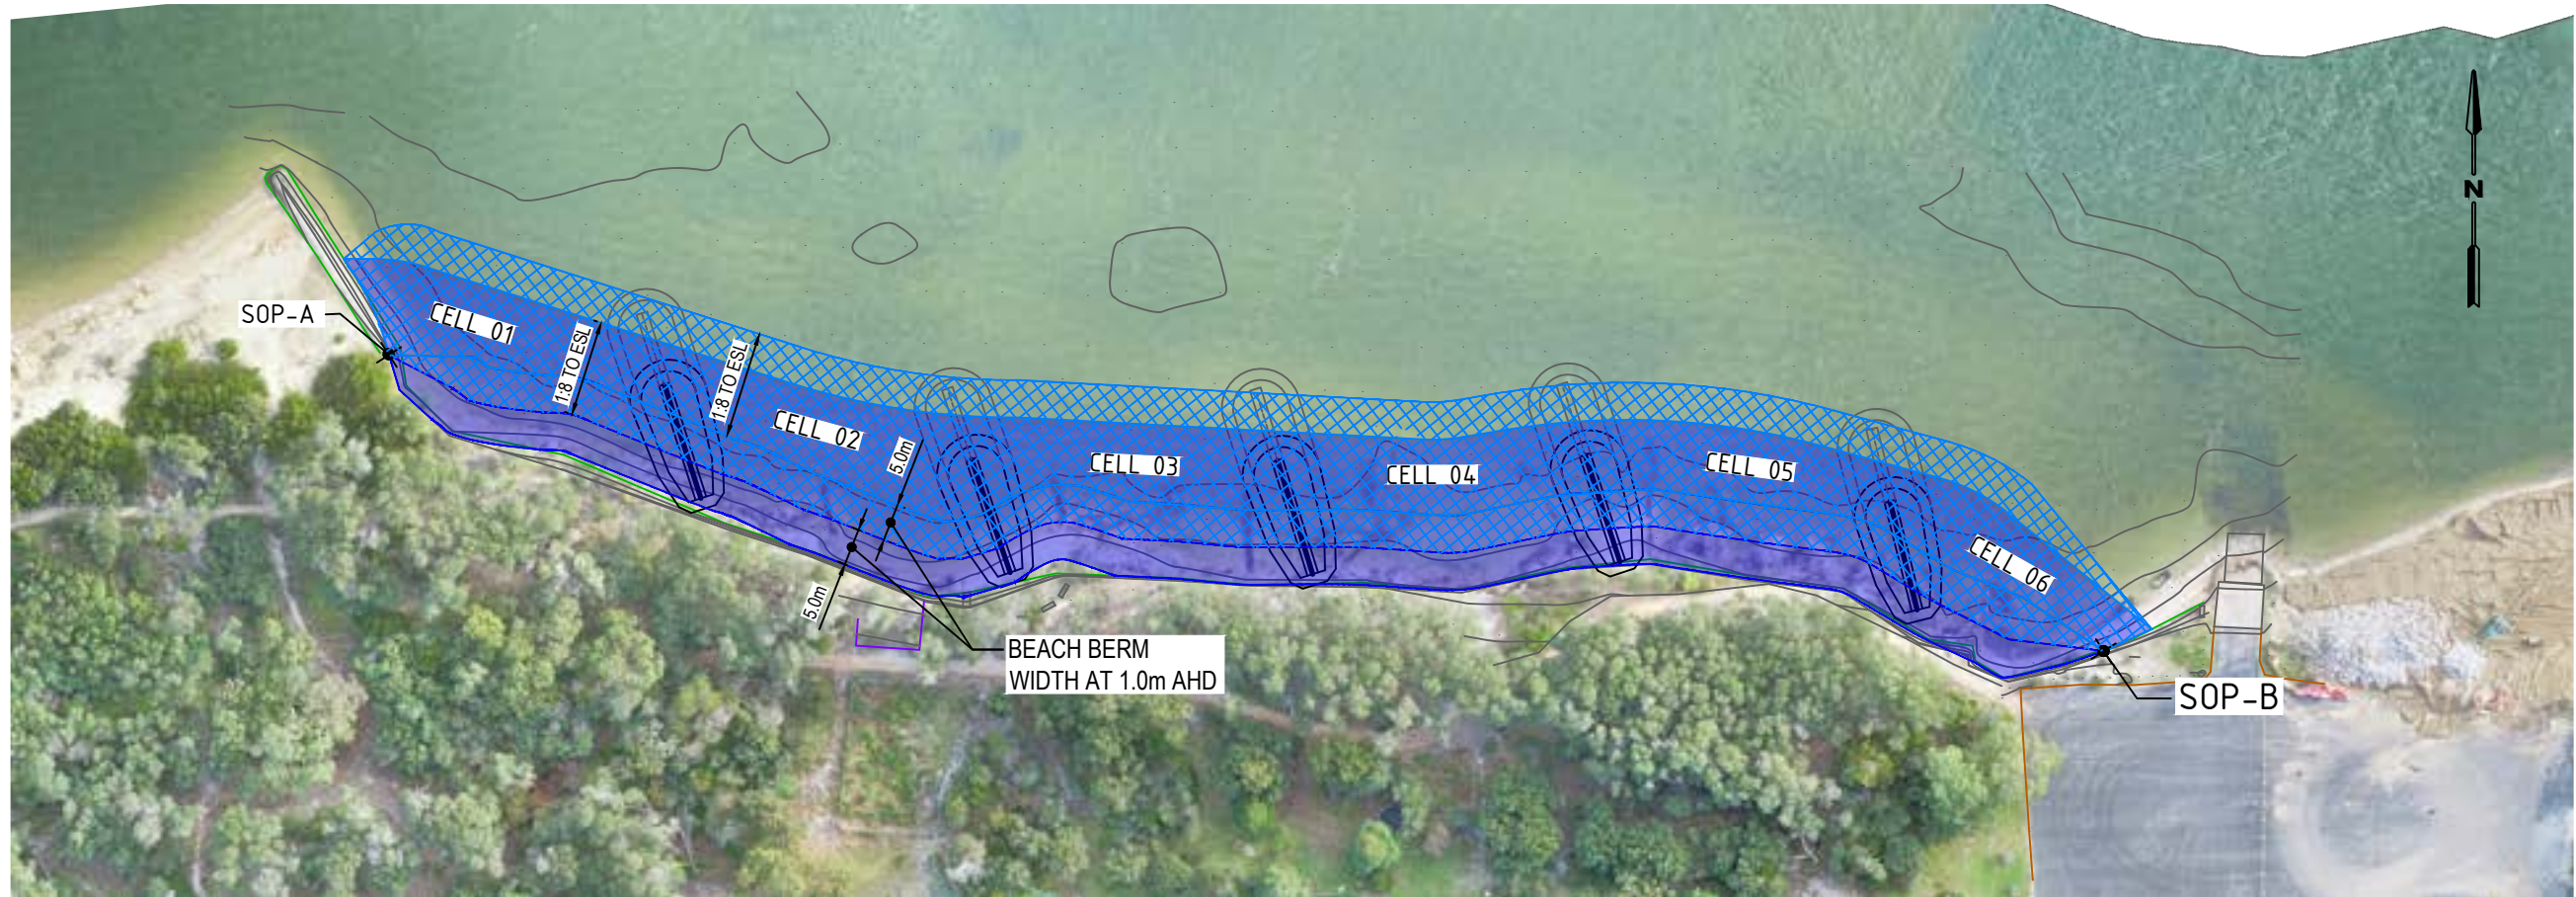
BEACH NOURISHMENT PLAN
SCALE 1:1000

STAGE 3 - BEACH NOURISHMENT			
POINT NUMBER	EASTING	NORTHING	EXISTING RL (AHD)
SOP-A	552026.652	5790134.663	1.0m
SOP-B	552250.838	5790198.594	1.0m
REFER TO NOTE 3 AND 4
